Ignition Timing Dwell & Backlash

By Lynn Sondena, Sandy, Oregon

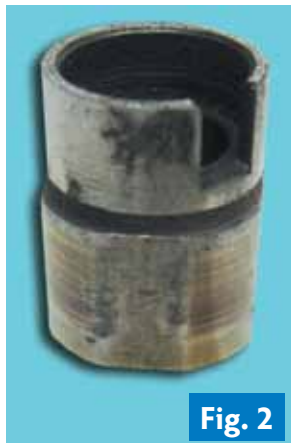
Fig. 2

An interesting fact that people probably know, but don't think about is that the distributor cam lobes are equal to the amount of cylinders in the engine. The Model A has four lobes on the distributor cam and four engine cylinders. **(Fig.2)**

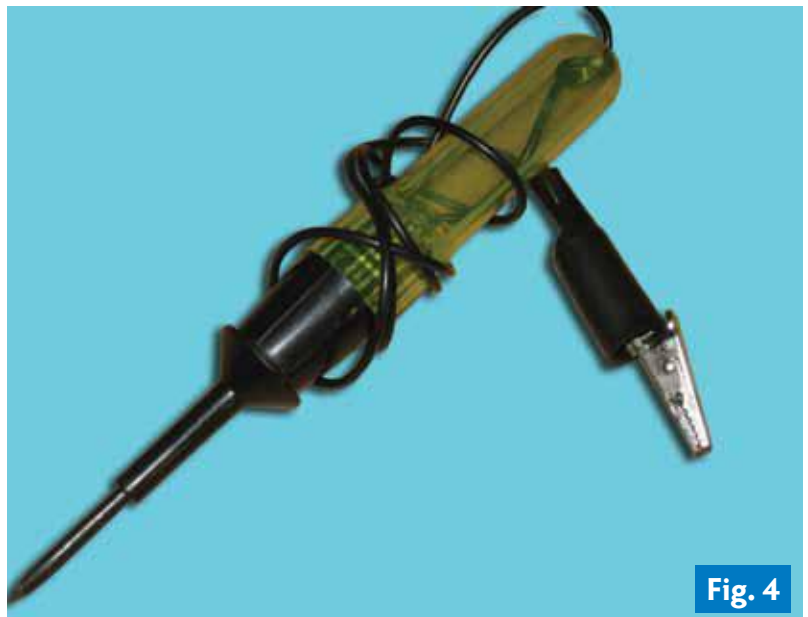
Fig. 4

The most accurate way to set the timing is to use a 6 volt/12 volt circuit tester light. These testers are available at any auto parts store and quite a few hardware stores. This job is best done with two people, although one person can complete the task. One person will operate the ignition key and spark lever. The second person will use the test light and set the distributor cam and rotor. **(Fig.4)**

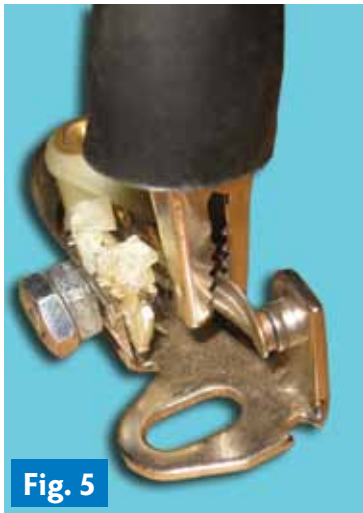
Fig. 5

7. Connect the test light to the point arm and ground. (I like to use the alligator clip of the test light on the point arm so that the sharp point of the tester will scratch

through oil and paint to obtain a good ground. (Fig.5)

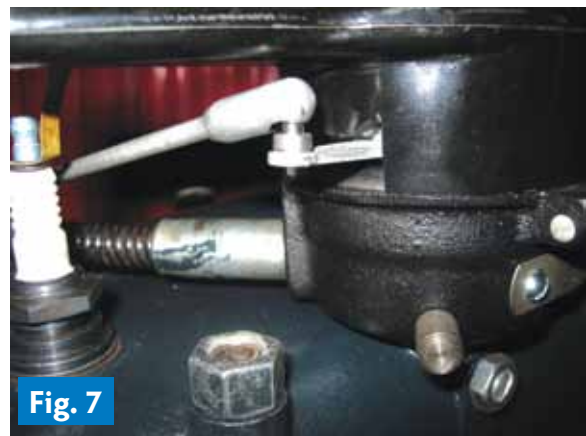
Fig. 7

There may be some cases when this process will need to be completed several times. Ideally a correctly timed Model A Ford will be at the first or second notch on the spark lever. One item that can affect the timing is a worn or loose upper bushing in the steering column. This would allow the spark and throttle levers to rotate several degrees causing problems. So check the two set screws to be sure they are tight on the upper column bushing. Also check to be sure that the steering column on a two tooth unit is connected tight to the gear box. (Fig.6). Check to see that the distributor arm has full swing between the distributor cap when the spark lever is advanced and retarded. (Fig.7)

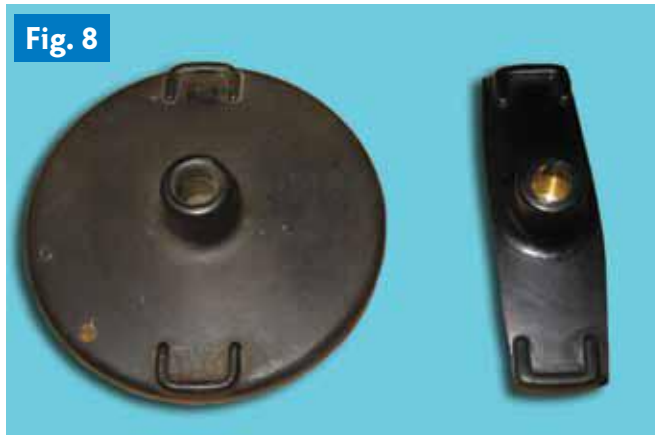
Fig. 8

One last note, if you really want to see what is happening inside your distributor take a distributor cap and cut it so that only the middle section is left (**Fig.8**). Replace the solid cap with this modified cap and start the engine. With the engine idling, you will be able to see the spark between the rotor and distributor body contacts. You will be able to see if it is sparking at the

leading edge, middle or trailing edge of the rotor. Also if you have any shorts in the point block you should be able to see that also. The Model A will need to be in a dark area, not bright sunlight. Do not run your Model A on the road with this cap; it is only for test purposes. The regular distributor cap is designed to keep out dirt and water from entering through the top to the inside of the distributor body. Also do not run your Model A in a confined space as carbon monoxide gas, which is colorless, odorless, and poisonous will kill!
