Don't Get Hosed

Simple inspections can prevent a breakdown that's been years in the making.

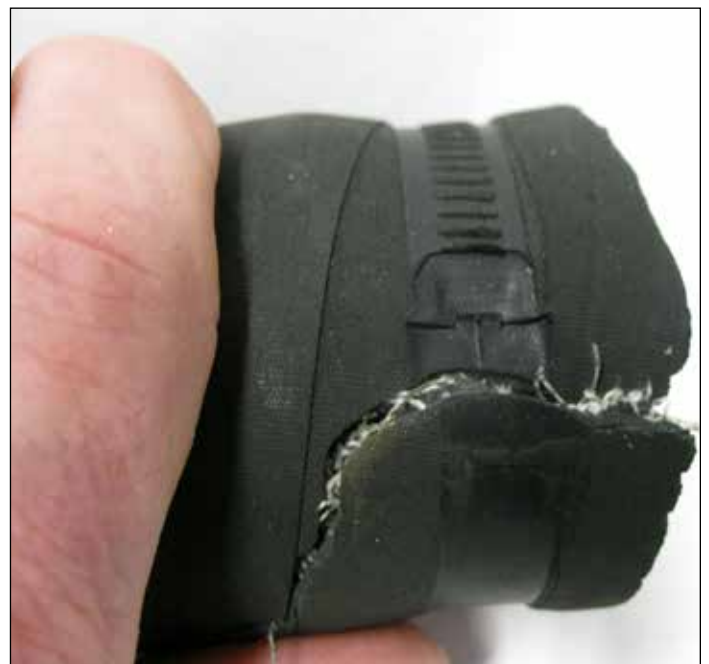
I inspected the radiator, and it was fine. The lower radiator hoses were good so I checked the upper radiator hose. It had dry rot cracks (photo 1) and on the bottom side, a two-inch-long tear (photo 2). The hose was 10 years old, so I replaced all of the radiator hoses.

Photo 2: On the bottom side of the hose I found a two-inch-long tear.

THE MORAL OF THIS STORY is to check your tires, radiator hoses, and fan belt for dry rot or cracks. If cracks are present, replace them. The work is a lot easier in your garage, where you have all the comforts of home.
